KENYA 2012

POST-TRIP REPORT

A JOINT COLLABORATION BETWEEN THE UNIVERSITY OF ILLINOIS AT URBANA-CHAMPAIGN,
UNIVERSITY OF NAIROBI, BONDO UNIVERSITY COLLEGE, AND BONDO DISTRICT WATER

CEE449
PROFESSOR BENITO MARÍÑAS
MARCH 12, 2012

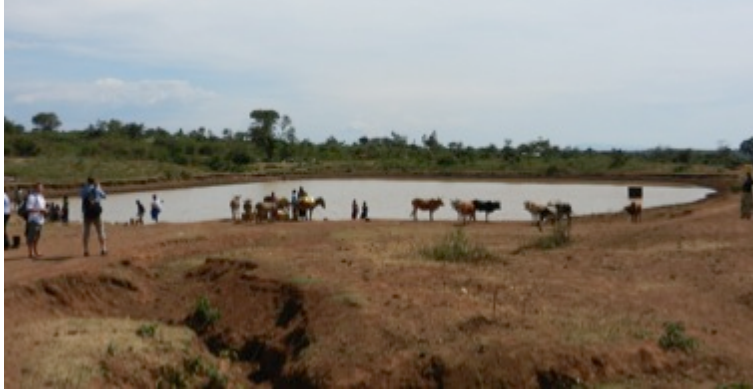
Figure 5. Awuor Pan

The pan itself was built in 1992 by a Swiss organization. The perimeter measures 46 x 27 meters, and the depth varies with season. Once the pan is full, the supply of water collected during each rainy season, in November and from March through May, generally lasts 1.5 months into the subsequent dry seasons, depending on use and precipitation. In 1997, a Dutch organization attempted renovations by digging a well, a second pan, and weir. The second pan, intended for sedimentation, was constructed adjacent to the first, with a 3 meter wide channel connecting the two. However, the channel was soon clogged by sediment, and lack of maintenance rendered the sedimentation pond useless. It is unclear why the well was never functioning.

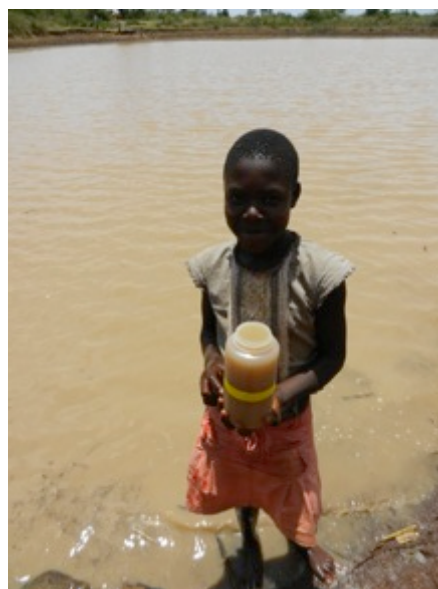
Figure 7. Local child collecting water sample from Awuor Pan

- **1.1: Awuor Pan.** Sample was taken directly from the Awuor Pan at the location where residents typically gather water (Figure 7).

Sample 1.1: Awuor Pan. Table 3 shows that the turbidity measured in the Awuor Pan exceeds the Kenya, WHO, and US EPA regulated values, and the fluoride value exceeded both the Kenya and WHO maximum contaminant levels (MCLs). The hardness was found to be 82.4 mg/L as CaCO₃, which is lower than the WHO and EPA recommended guidelines that range from 100 to 300 mg/L as CaCO₃. There was 0.08 mg/L of iron found in the water, which exceeds the Kenya MCL of 0.05 mg/L. However the recommended iron MCL is a preference of taste and odor rather than contamination. The fluoride, iron, and hardness are naturally present in the minerals. Additionally, total and fecal coliforms were present, indicating that the microbiological contamination in the water could lead to illnesses like diarrhea.

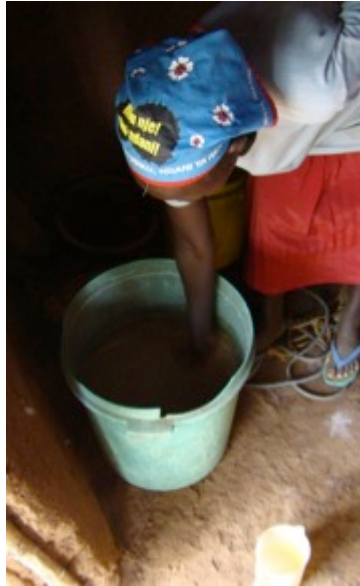
Figure 8. Margaret Abongo showing the use of dawa in her multi-purpose water

- **1.2: Margaret Abongo's multi-purpose water.** Sample was taken from a storage tank in Margaret Abongo's home. She had collected the water from the Awuor Pan water, added dawa for 30 seconds and allowed it to settle for 5-10 minutes (Figure 8). She uses this water for washing dishes and clothes and cooking.

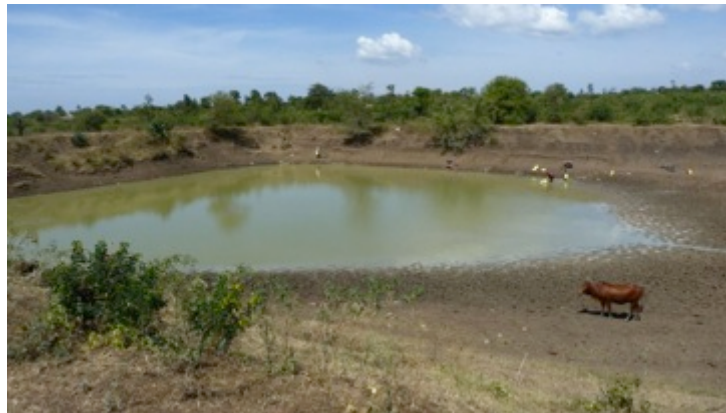
Figure 10. Majengo Pan

The Majengo Pond is managed by a water committee. They organize events to maintain the pond and make decisions regarding its use. In times of low water availability, they have people guard the pond so no livestock can access it. According to the chairman of the water committee, many animals perish as a result of this policy. At the time of the visit, the pond had receded significantly and the chairman was concerned about it drying out, despite the fact that the rainy season was expected to begin in a few weeks.

Community members recognized that the water coming from the Majengo Pan was harmful to their health, and they acknowledged that it causes stomach pains and sickness. They have witnessed feces and diseased animals in the water. There were also water education seminars organized in the area at least once a month. Despite this, many people did not treat the pan water before drinking. This is because the community viewed as WaterGuard expensive and resulting in a bad taste. Some community members filtered the pond water with cloth but

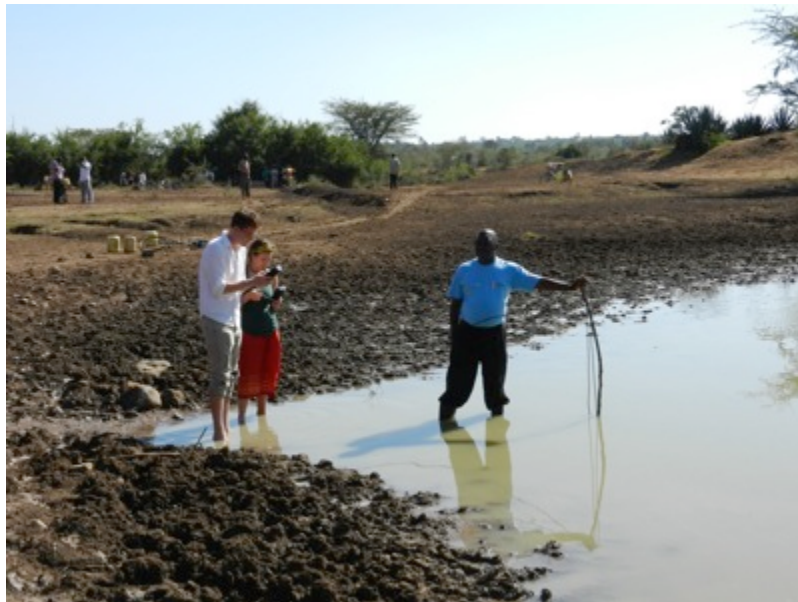
Figure 11. UIUC and UoN students testing water at Majengo Pan where samples were taken

- **2.1: Majengo Pan.** Sample taken directly from the Majengo Pan where residents typically gather their water (Figure 11).

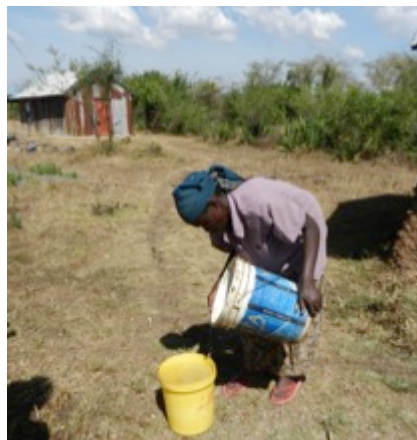
Figure 13. Rebeka Achieng Opany showing how she separates pond water from settled particles

- **2.3: Rebeka Achieng Opany's untreated & transferred drinking water.** Sample taken from the same jerrycan as Sample 2.2, but it was first transferred to a 5-gallon bucket and then scooped with a cup into a pitcher; simulates handling of water before drinking (Figure 12).
- **2.4: Rebeka Achieng Opany's multi-purpose water.** Sample taken from 5-gallon bucket used to allow Majengo Pan water to settle and cool overnight (Figure 13 and Figure 14).

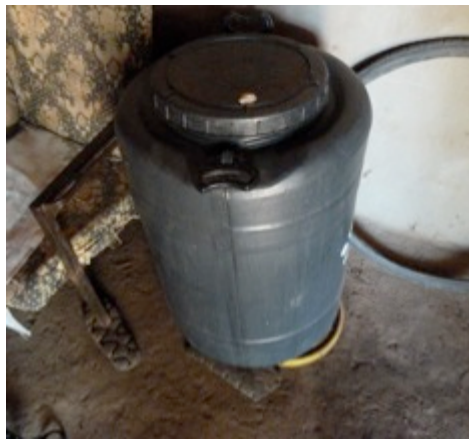
Figure 16. Chairman's drinking water storage container called a super drum

- **2.5: Chairman's drinking water.** Sample taken from super drum. Water taken from Akoko kiosk and transported by jerrycan (Figure 16).

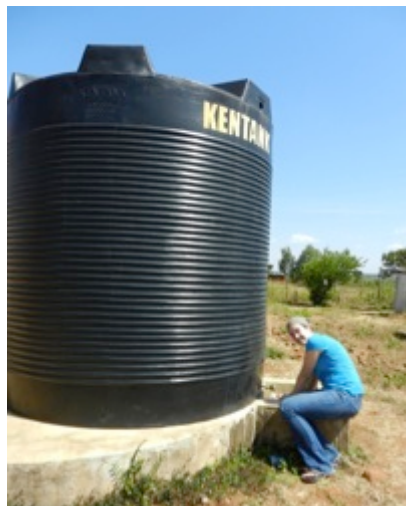
Figure 18. Storage tank collecting rainwater at Mabinju Dispensary

- **3.1: Dispensary's multi-purpose water.** Sample taken from spigot at base of closed tank used to store rainwater (Figure 18).

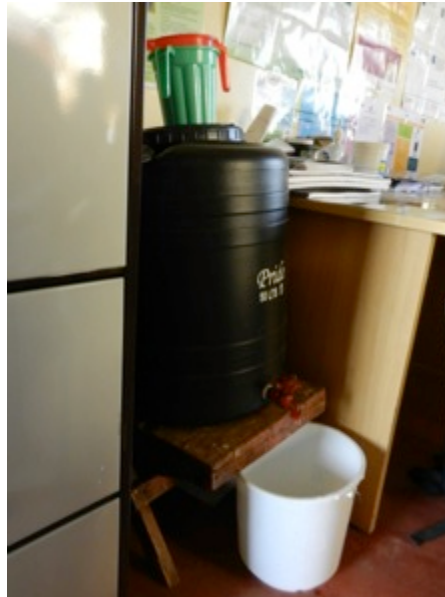
Figure 19. Storage container for treated drinking water at Mabinju Dispensary

- **3.2: Dispensary's drinking water.** Sample taken from spigot of closed container used to store rainwater treated with WaterGuard (Figure 19).

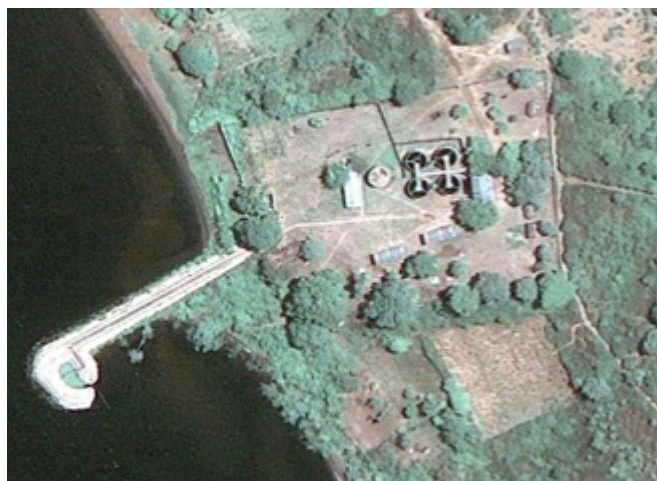
Figure 20. Lake Victoria water treatment plant

Site 4: Lake Victoria Treatment Plant. The Lake Victoria water treatment plant, as shown in Figure 20, is located in the South Sakwa Sub-Location in the Nyangoma Division of Bondo. The project was first initiated in 1978, and the treatment plant was commissioned in 1993. The current system provides water for about 10,000 people and pumps 600 cubic meters per day to 11 kiosks and 379 communal water points. The distribution network covers approximately 28 square kilometers and is increasing as more water kiosks and communal water points are being installed.

The treatment plant can only be reached by a small service path about 0.5 km from the nearest road. If maintenance and operational changes are recommended, accessibility could be a hindrance. Much of the site has swarms of bees, flies, and birds that surround many of the building entrances.

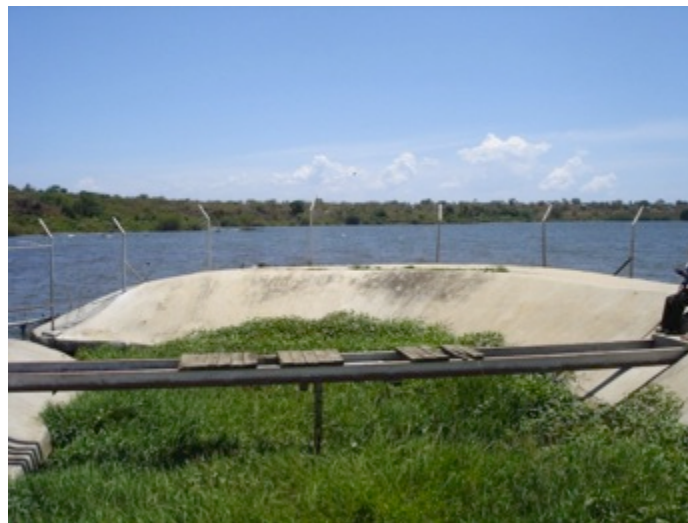
Figure 21. Concrete sump at treatment plant intake

The original intake was a 135 cubic meter concrete sump. As the water level in Lake Victoria began to decrease, the concrete sump became inoperable. As seen in Figure 21, the concrete sump was filled with weeds, and the current intake system was comprised of one 100 millimeter intake pipe that drew water from Lake Victoria by a submersible pump. The pump is capable of pumping 85 cubic meters per hour. The initial design included three pumps, two of which are presently inactive. As shown in Figure 22, the water from Lake Victoria is pumped toward the treatment plant.

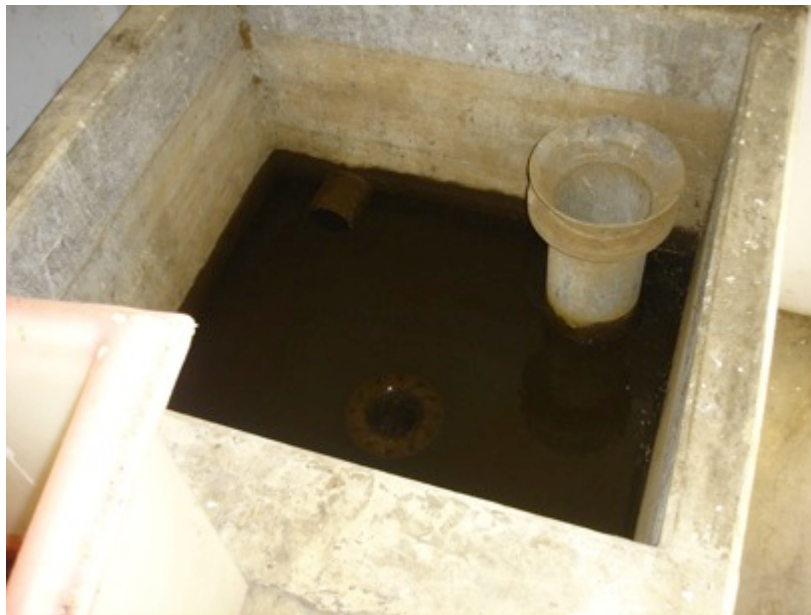
Figure 23. Mixing tank

The water conveyed from the Lake Victoria reached the mixing tank (Figure 23) located on the second floor of the water treatment plant office. This was originally designed as the location for addition of coagulant. Currently, water was allowed to flow directly to the coagulation tanks. The water treatment plant operator and local official stated their opinion that the water is not turbid enough to justify the use of coagulant.

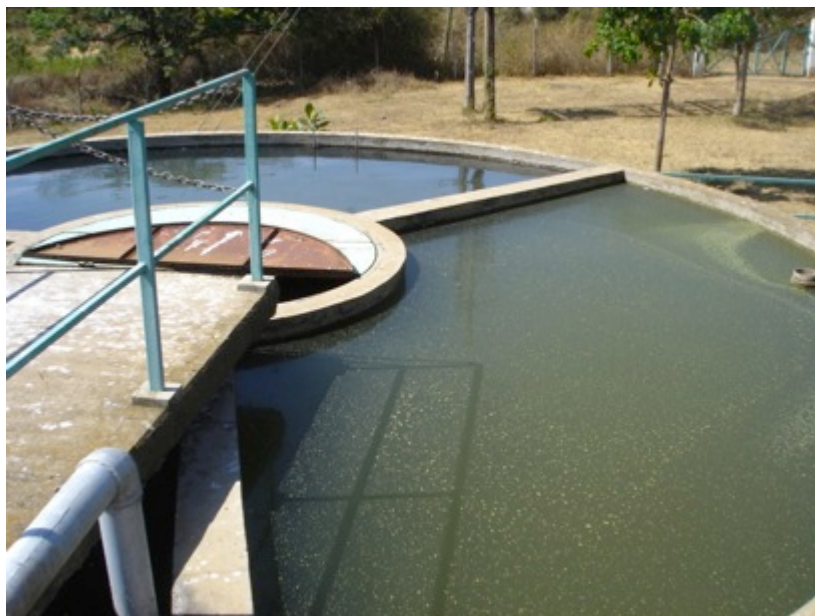
Figure 24. Coagulation tank showing algae growth on water surface

After the flow has been directed around the coagulation tank, it enters filtration through the pipe in Figure 25. Filtration occurs in a separate tank in the middle of the coagulation tank (covered by a metal plate as shown in Figure 24). These tanks look well designed but are in need of maintenance. Some of the pipes are corroded, stagnant water is causing algae to form in some of the wells as shown in Figure 24, and in Figure 26 the coagulation basin is leaking.

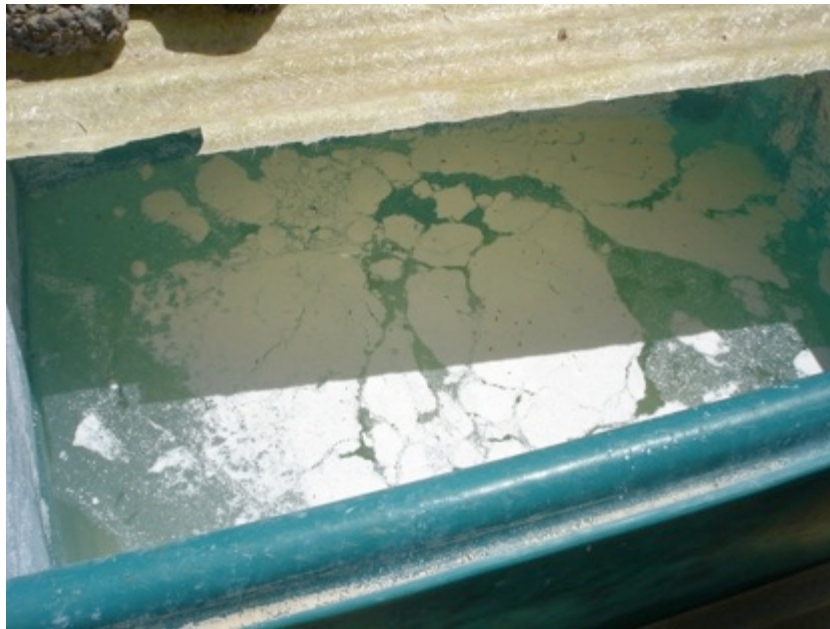
Figure 27. Calcium hypochlorite mixing with water

hypochlorite is added to water (Figure 27) and then drained into the clear water tank through a hose. At the base of the box, there is a small valve that regulates the flow of the disinfectant.

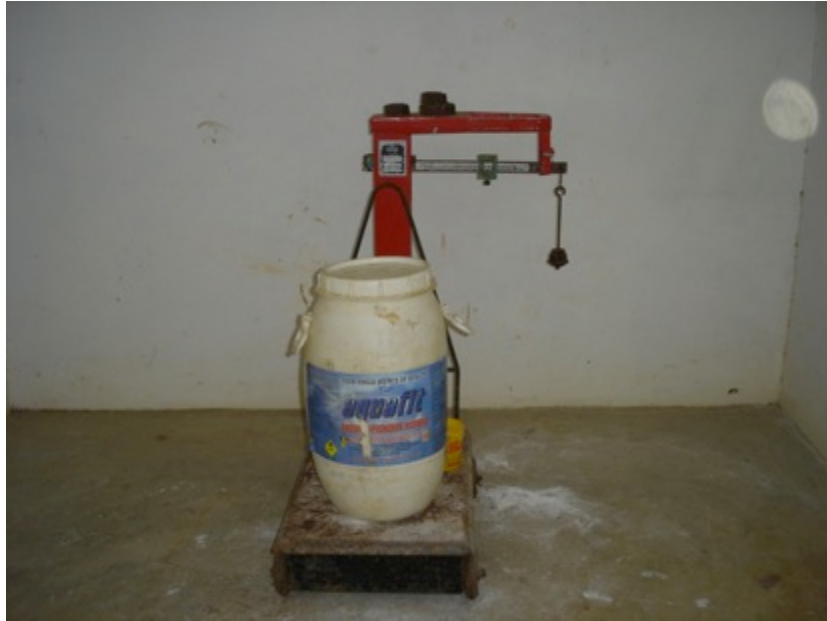
Figure 28. Powder form of calcium hypochlorite

There are currently no clear operating guidelines for the disinfection process. After speaking with the operator, he had been advised to add 1.5 kilograms of calcium hypochlorite (powder form shown in Figure 28) and water to the box every morning at 5 am and ensure that all disinfectant has drained by 6 pm. The flow rate of disinfectant to the tank is only regulated based on the operator's daily judgment of how quickly the solution is draining. At 6 pm, the operator turns off the plant until 5 am the next morning when he repeats the process of adding calcium hypochlorite to water in the box. The district manager says that more disinfectant is added during the dry season, but no specific value could be provided.

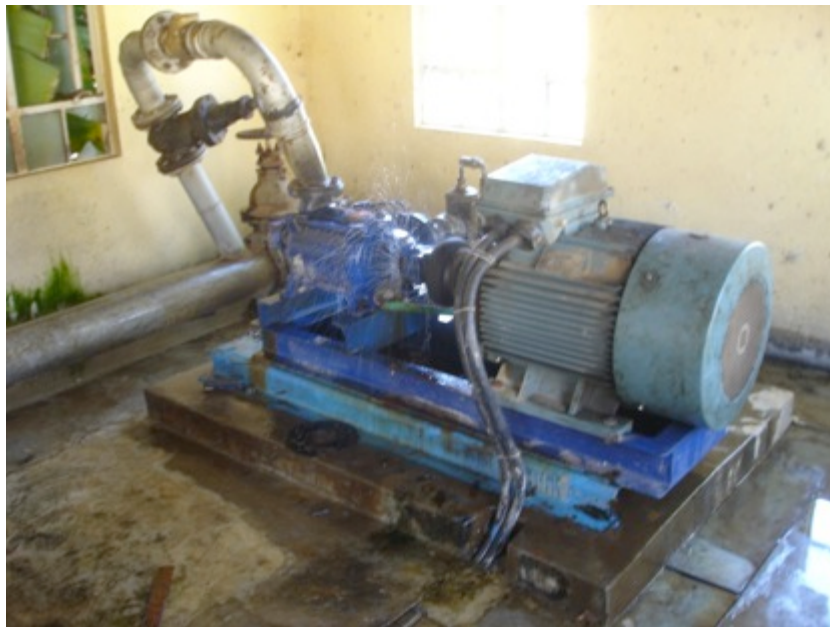
Figure 29. Leaky pump

Water is pumped from the clear well to distribution tanks located 2.45 kilometers from the treatment plant. The treatment plant originally utilized three high lift pumps that were capable of pumping at 65 cubic meters per hour. There is only one pump that is currently in operation. The pump that is currently in operation is leaking quite a bit as shown in Figure 29. The energy loss due to this issue cannot be calculated, but the leak is most likely increasing operational costs and limiting water output.

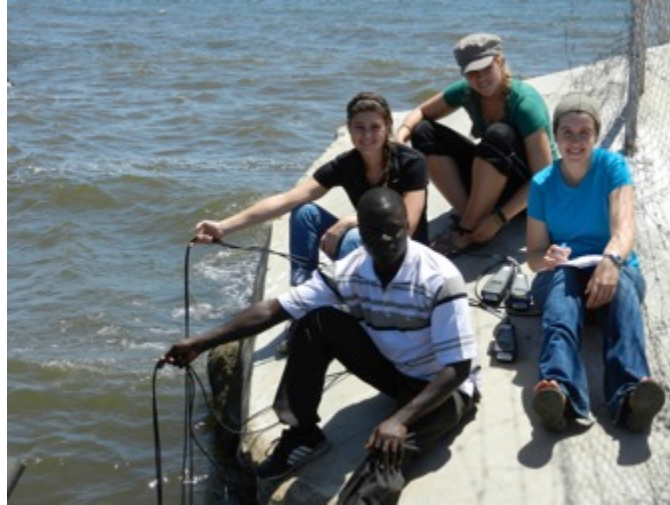
Figure 30. Collecting water quality data at inlet to water treatment plant.

- **4.1: Influent to the water treatment plant.** Sample was taken from water at concrete sump near influent pipe in Lake Victoria (Figure 30).

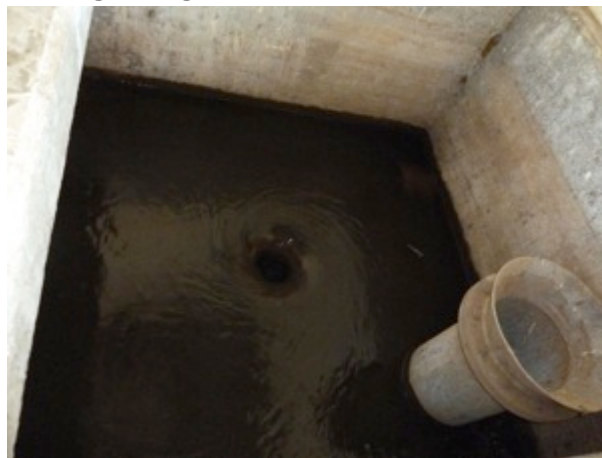
Figure 31. Mixing tank for potential coagulant application

- **4.2: Effluent from the water treatment plant.** Sample was taken after clear water basin in which chlorine is added. The pump to storage tanks was turned off, and the sample was taken directly at the pump outlet.
- **4.3: Mixing tank water.** Sample taken from the mixing tank (Figure 31). Water pumped from the lake enters here and then travels to the coagulation basins. If the treatment plant were using a coagulant, this is where it would be added.

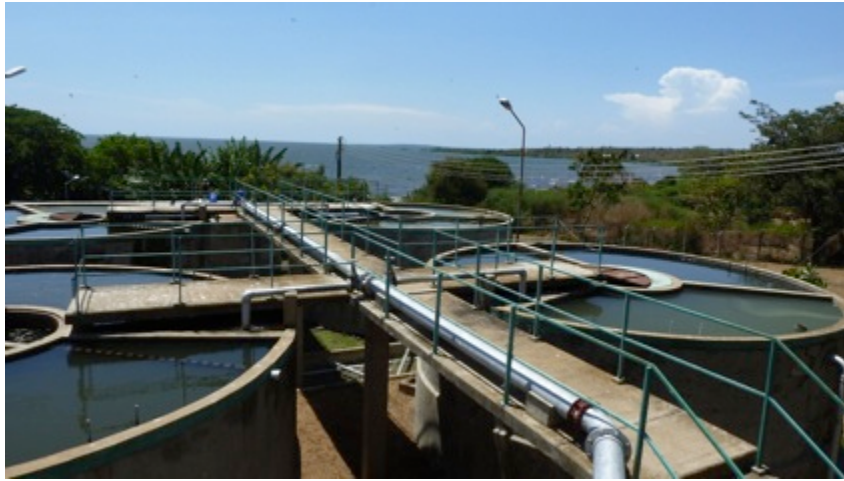
Figure 32. Coagulation basins

- **4.4: Coagulation basin.** Sample was taken from the far right coagulation basin in Figure 32. The sampled water had passed through the coagulation basin but not yet through the filtration media.

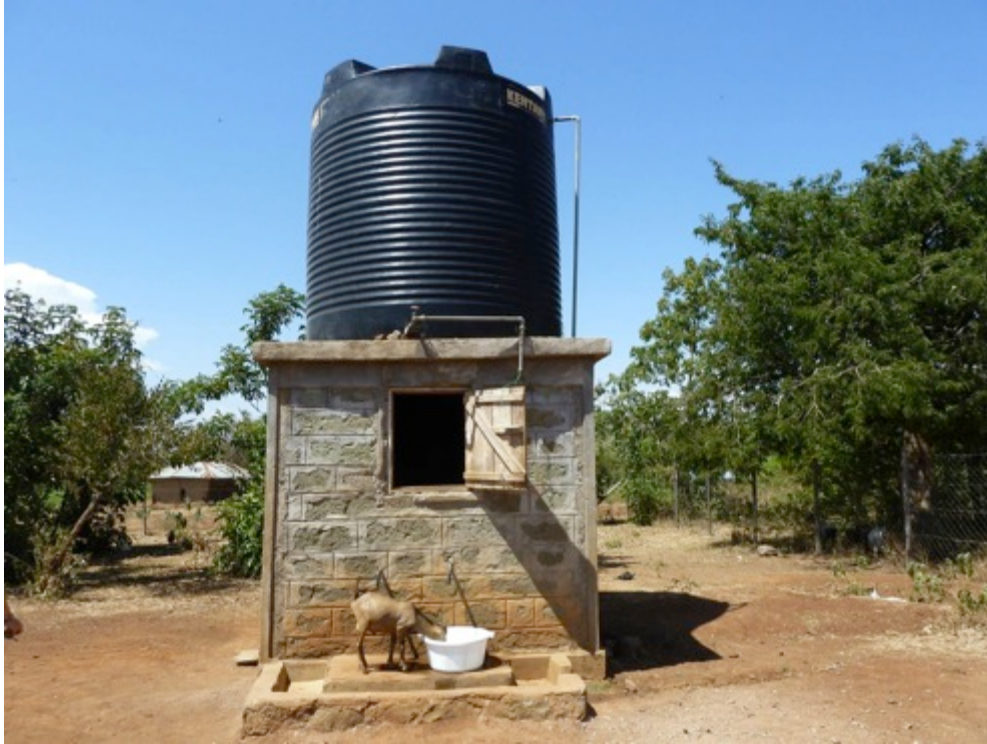
Figure 33. Waye community water kiosk

- **4.5: Kiosk.** The Waye Community Development Kiosk is located about 2 kilometers east of the water treatment plant and is shown in Figure 33. It was constructed 3 years ago by the NGOs Western Flood Mitigation and World Bank. The community had offered the land to construct the kiosk. The area was fenced in and consisted of a kiosk with a 10 cubic meter tank, 2 troughs for animals (Figure 34), a latrine center, and additional land designated to start a community garden. The kiosk is run by a committee of 11 community members and consists of a chairman, secretary, treasurer, operator, and 7 members. All positions are unpaid except for the operator, whom earns 700 KSH a month for spending approximately 60 hours per week at the kiosk. Water currently costs 5 shillings per 20 L jerrycan. The purpose of the kiosk was intended to supply water to the community, but it has yet to do so as the lack of customers, price of water, and unreliability of the water from the kiosk are all prohibitive issues. The kiosk is connected to the distribution system that supplies the entire community. Whenever there is a pipe leak or disconnection, the water treatment plant must turn off the entire distribution system to fix the one problem. It usually takes 2-3 days for a pipe to be fixed, which is a sufficient amount of time for the tank to run dry. The electricity is also unreliable, and if electricity is not available, the tank can run dry in about 2 days. Alternative water sources in the area include Lake Victoria, private homes with water connections that sell water, and other nearby kiosks.

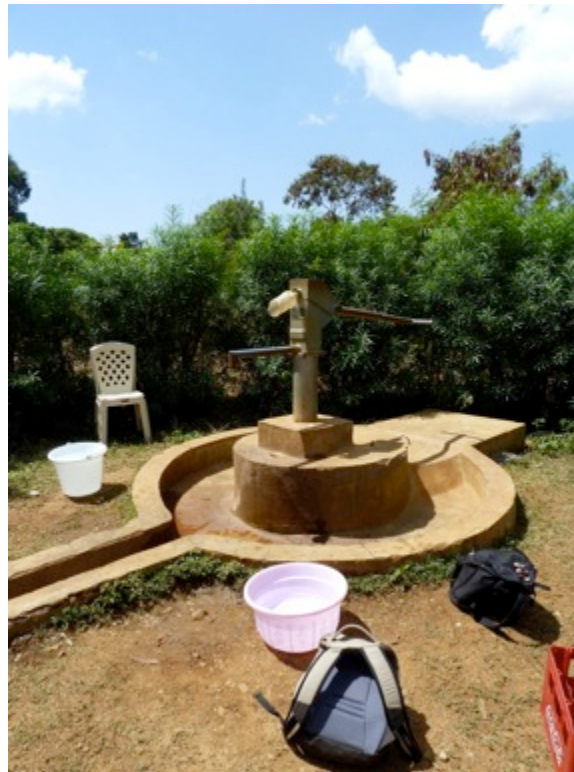
Figure 35. Yawo Shallow Well

Site 5: Yawo Shallow Well. The Yawo Shallow Well (Figure 35), measuring 70 feet in depth, was first built in 1996 by Catholic missionaries from the. At the time of its construction, both the men and women of the village were provided with three weeks of training on pump usage. It broke down in 2005 and was repaired by UNICEF within the year. The Nyandiek Women's Group was then formed to manage the distribution of water. Water was collected using a funnel and a jerrycan and is primarily used for drinking and cooking. Other sources such as the nearby pond were used for washing.

Sample 5.1: Yawo Shallow Well. Of all of the sites tested, the Yawo Shallow Well water quality data was the most encouraging. As shown in Table 7, only the fluoride and manganese levels were higher than regulatory limits. Although it had a measured fluoride concentration of 1.65 mg/L, which lies above Kenya regulations, it does fall below the US requirement. As expected, the shallow well did have a high concentration of manganese at a value of 0.9 mg/L, which falls above all regulations. This data is consistent because infiltrating groundwater gets naturally filtered through the earth's crust, lowering some contaminant levels. No fecal coliforms were found in the well water, but total coliforms were still present in low concentrations. This indicates that the well water is much safer than other sources but still requires some form of disinfection to ensure its quality.

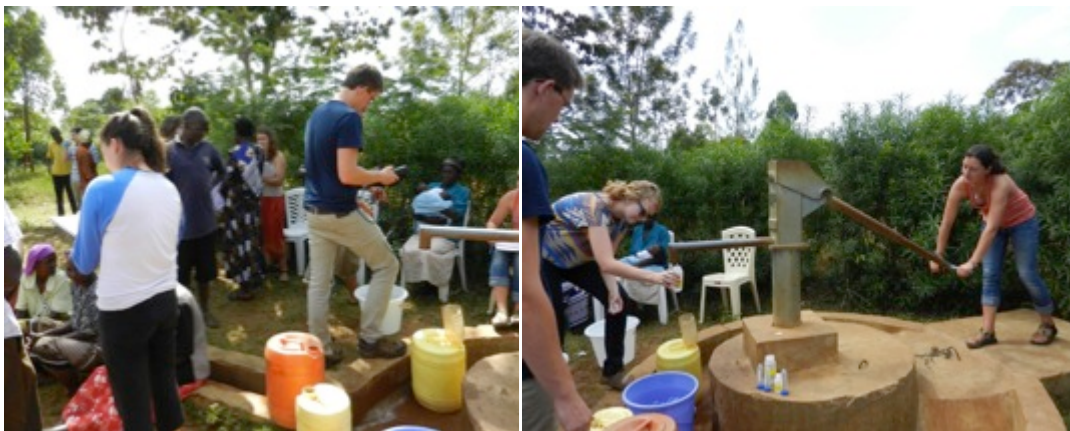
Figure 36. Sampling from Yawo Shallow Well

- **5.1: Yawo shallow well.** Sample taken directly from spigot of well pump (Figure 36).

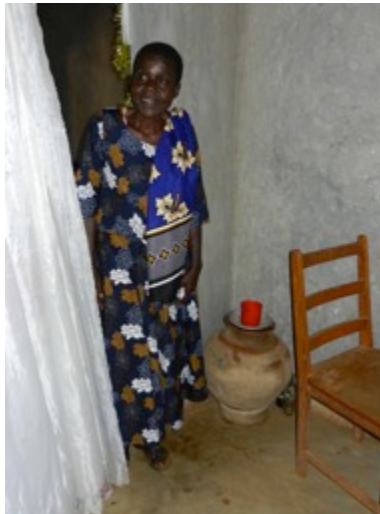
Figure 37. Risper Atieno's drinking water storage and collection of sample

- **5.2: Risper Atieno's drinking water.** Sample taken from closed clay pot and scooped out with cup (Figure 37). Water taken from Yawo shallow well.

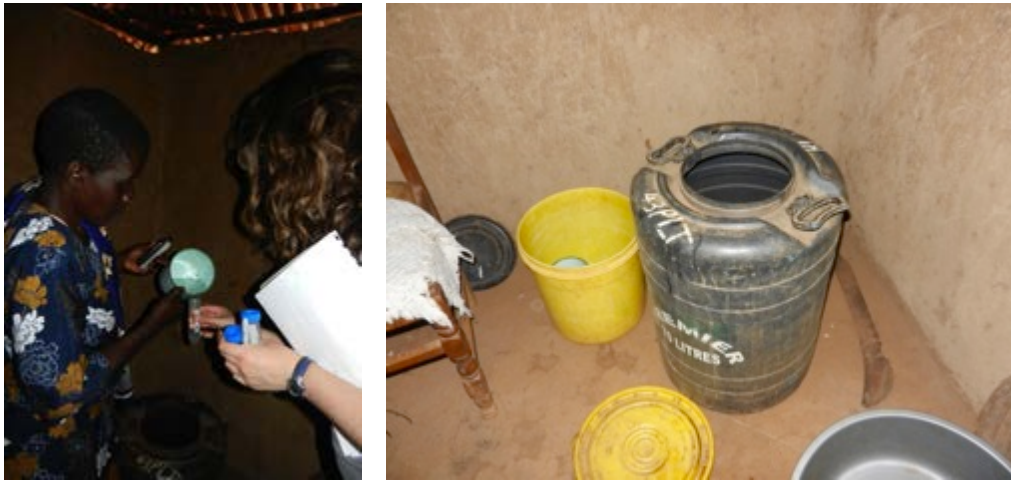
Figure 39. Risper Atieno's neighbor #2's water storage

- **5.4: Risper Atieno's neighbor #2's water.** Sample taken from open 5-gallon bucket storing water from Yawo shallow well (Figure 39).

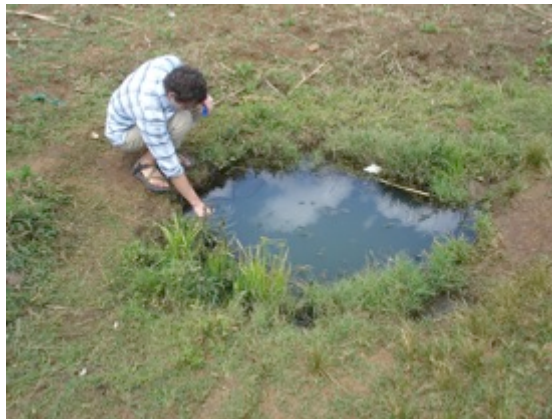
Figure 40. Spring near the Yawo Shallow Well

- **5.5: Spring water.** Sample taken from natural spring about 0.5 km from well (Figure 40). Water is used as drinking water.

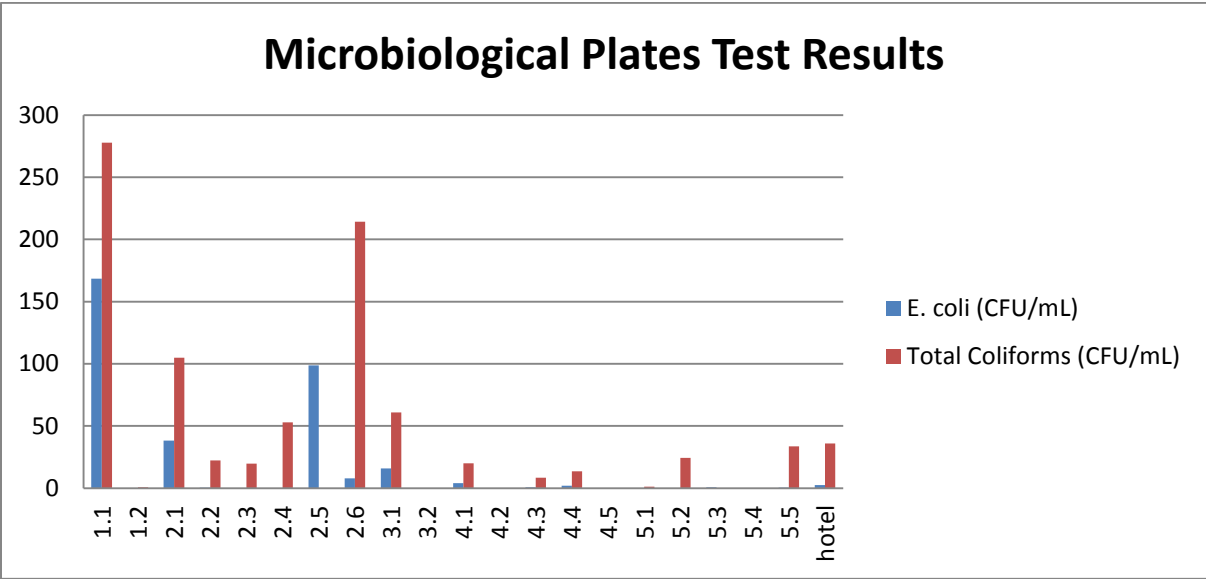
Figure 50. Summary of results from microbiological plate testing (Note: Samples 2.5, 5.3, and 5.4 contained too many Total Coliforms to count.)

Sample	<i>E. coli</i> (CFU/mL)	Total Coliforms (CFU/mL)	Sample	<i>E. coli</i> (CFU/mL)	Total Coliforms (CFU/mL)
1.1	155	210	3.1	19	53
1.1	120	192	3.1	14	65
1.1	127	169	3.1	15	65
1.1	165	240	3.2	0	0
1.1	210	320	3.2	0	0
1.1	210	340	3.2	0	0
1.1	170	310	4.1	3	20
1.1	160	280	4.1	7	23
1.1	200	440	4.1	2	17
1.2	0	0	4.2	0	0
1.2	0	0	4.2	0	0
1.2	0	2	4.2	0	0
2.1	32	77	4.3	0	1
2.1	29	66	4.3	2	16
2.1	28	56	4.3	0	8
2.1	30	150	4.4	0	12
2.1	100	200	4.4	0	14
2.1	10	80	4.4	6	15
2.2	1	19	4.5	0	0
2.2	0	18	4.5	0	0
2.2	0	30	4.5	0	0
2.3	0	12	5.1	0	1
2.3	0	25	5.1	0	2
2.3	0	22	5.1	0	1
2.4	0	68	5.2	0	24
2.4	0	43	5.2	0	28
2.4	0	48	5.2	0	21
2.5	88	TNTC	5.3	0	TNTC
2.5	98	TNTC	5.3	1	TNTC
2.5	110	TNTC	5.3	1	TNTC
2.6	6	159	5.4	0	TNTC
2.6	7	162	5.4	0	TNTC
2.6	4	165	5.4	0	TNTC
2.6	10	230	5.5	0	30
2.6	20	270	5.5	1	34
2.6	0	300	5.5	0	37
			hotel	1	36
			hotel	4	36
